Upper-Story Windows

Upper Story Windows

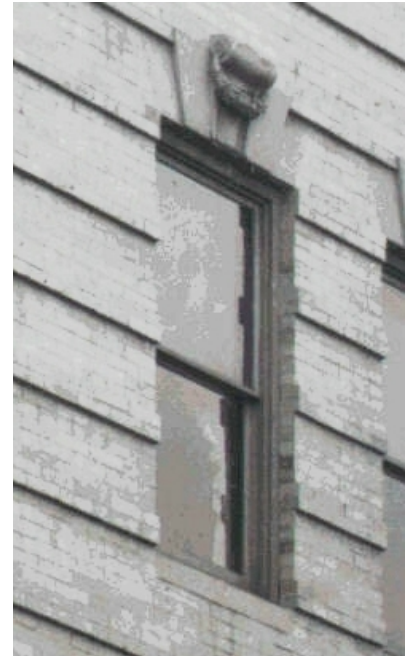
Recommended: Preserve historic upper-story windows. This early photograph shows a window with typical 1/1 double-hung sash.

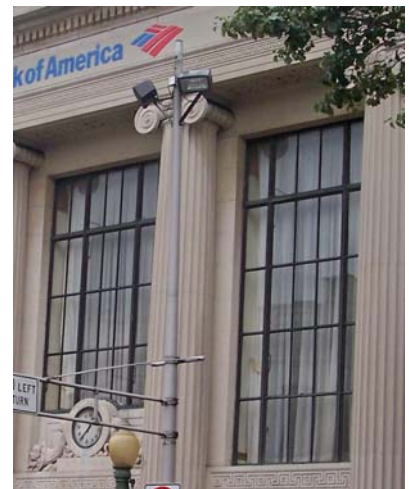
Recommended: Preserve original window sash. The bank at 56 East Ridgewood retains the multi-paned metal windows installed when the building was erected in 1930.

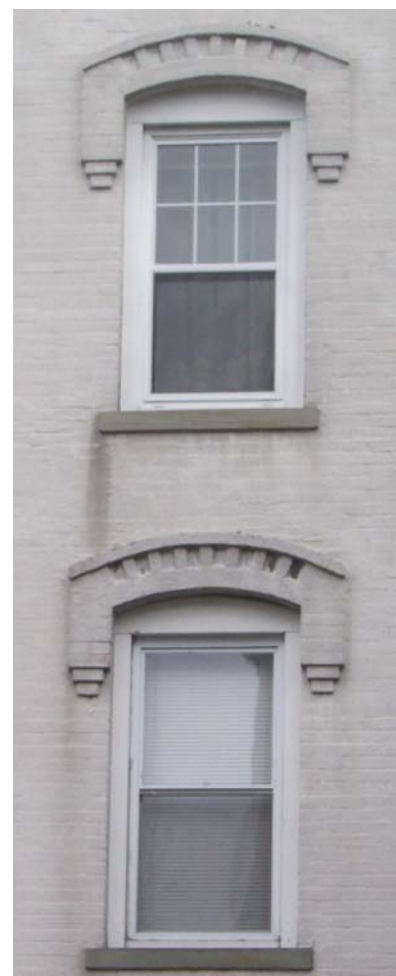
Not Recommended: Using sash with inappropriate division of panes. The upper-sash with new 6/1 sash does not match with the lower 1/1 sash.

- Blocking or filling in original window openings.
- Adding additional non-historic window openings.
- Changing the size or shape of a window opening.
- Sash with inappropriate division of panes. (For example, it is inappropriate to replace a historic 6/1 sash with a 1/1 sash. It is inappropriate to replace a historic 1/1 double hung sash with a single pane of glass.)

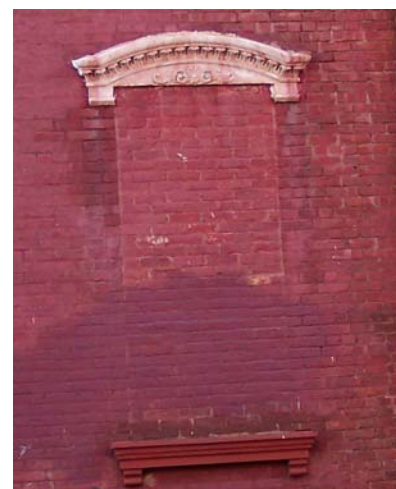
Not Recommended: Blocking or filling-in window openings.

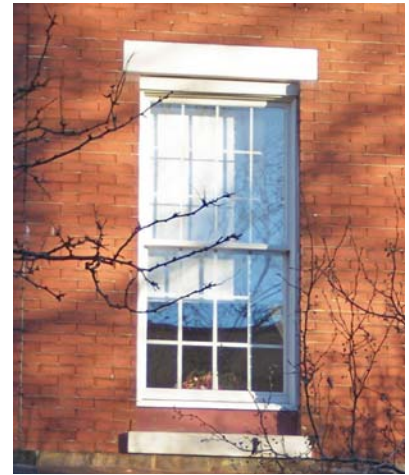
Not Recommended: Using stock windows and storms that require blocking part of the openings and using snap-in muntins.

- Flat muntins inserted onto the panes (“snap-ins”).
- Installation of shutters when no documentary evidence exists for them. If shutters are installed they have to be the correct size and style to appear to close.

- Unpainted metal storm windows.
- Stock size storm windows that require reducing the opening's size.

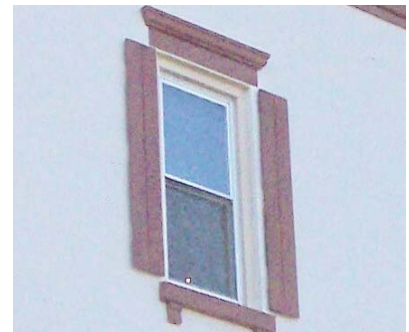
Not Recommended: Using shutters where there is no evidence for their historic use and that are too narrow and so clearly cannot function.
